COMMUNITY MAP

LOWER KALSKAG

61°31'N 160°21'W Elevation 49' (at airstrip)

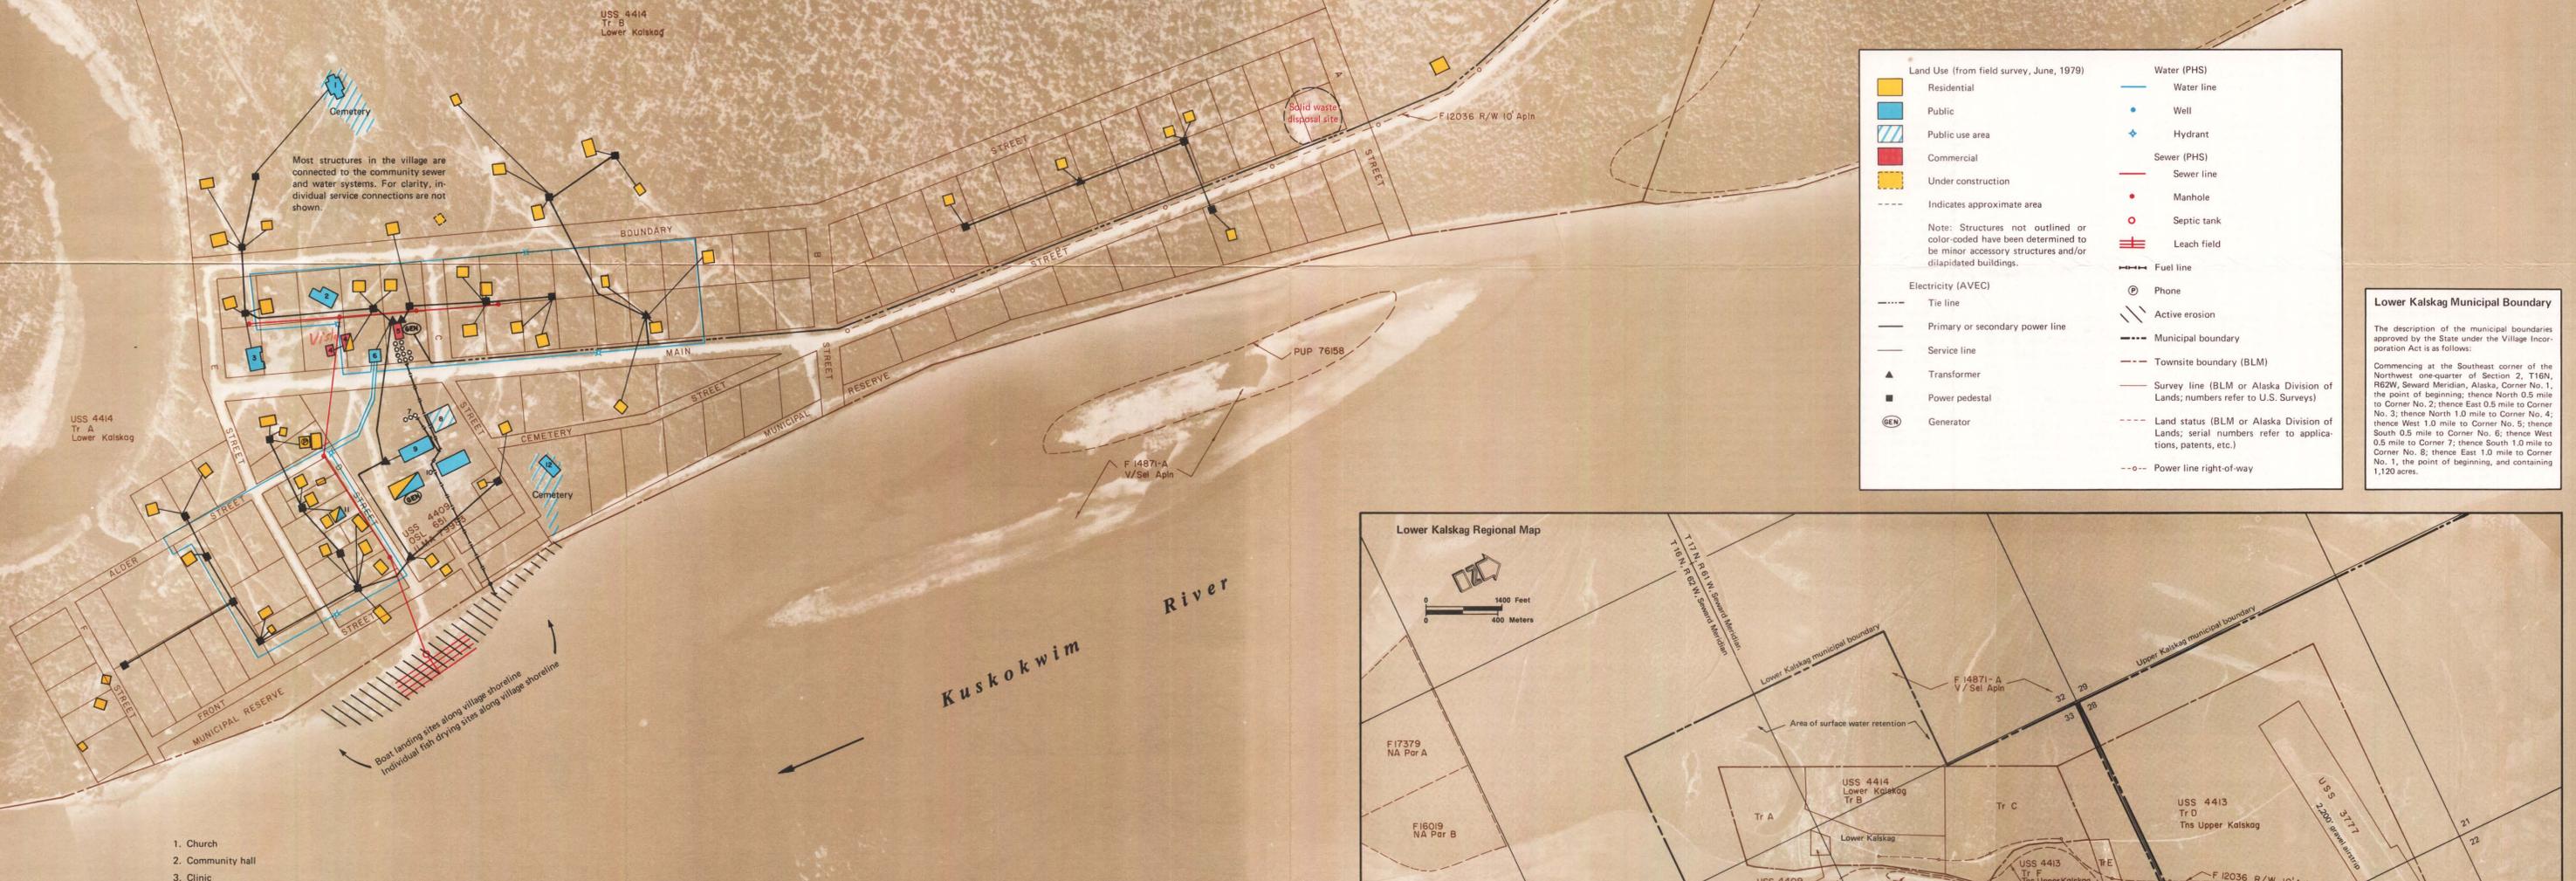
Residential	Water (PHS) Water line
Public	Well
Public use area	Hydrant
Commercial	Sewer (PHS) Sewer line
Under construction	Manhole
Indicates approximate area	Septic tank
Note: Structures not outlined or color-coded have been determined to be minor accessory structures and/or dilapidated buildings.	Leach field
Note: Structures not outlined or color-coded have been determined to be minor accessory structures and/or dilapidated buildings.	Fuel line
Note: Structures not outlined or color-coded have been determined to be minor accessory structures and/or dilapidated buildings.	Phone
Note: Structures not outlined or color-coded have been determined to be minor accessory structures and/or dilapidated buildings.	Active erosion
Note: Structures not outlined or color-coded have been determined to be minor accessory structures and/or dilapidated buildings.	Municipal boundary
Note: Structures not outlined or color-coded have been determined to be minor accessory structures and/or dilapidated buildings.	Township boundary (BLM)

Note: Structures not outlined or color-coded have been determined to be minor accessory structures and/or dilapidated buildings.	Survey line (BLM or Alaska Division of Lands; numbers refer to U.S. Surveys)
Note: Structures not outlined or color-coded have been determined to be minor accessory structures and/or dilapidated buildings.	Land status (BLM or Alaska Division of Lands; serial numbers refer to applications, patents, etc.)
Note: Structures not outlined or color-coded have been determined to be minor accessory structures and/or dilapidated buildings.	Power line right-of-way

Electricity (AVEC)

- Tie line
- Primary or secondary power line
- Service line
- Transformer
- Power pedestal
- Generator

- Church
- Community hall
- Clinic
- Store
- AVEC power plant and fuel storage tanks
- PHS well and pumphouse
- Fuel storage for school
- Recreational platform
- Junior high school
- Elementary school complex
- Post office
- Church
- Store
- Fuel storage

The Community Map shown here was prepared from a U.S. Army Corps of Engineers aerial photograph taken in 1977 at a height of 2,400 feet and enlarged to a scale of 1:2,400 (1 in. = 200 ft.). This map has been used to locate the present utilities, residential and commercial development, public facilities and to portray other information which will aid in evaluating the area for new construction and potential village expansion.

Community Map—Maps are useful in illustrating land use patterns, ownership, location of utilities and in planning for future village improvements. These maps can be prepared by surveying the land and/or by enlarging aerial photographs.

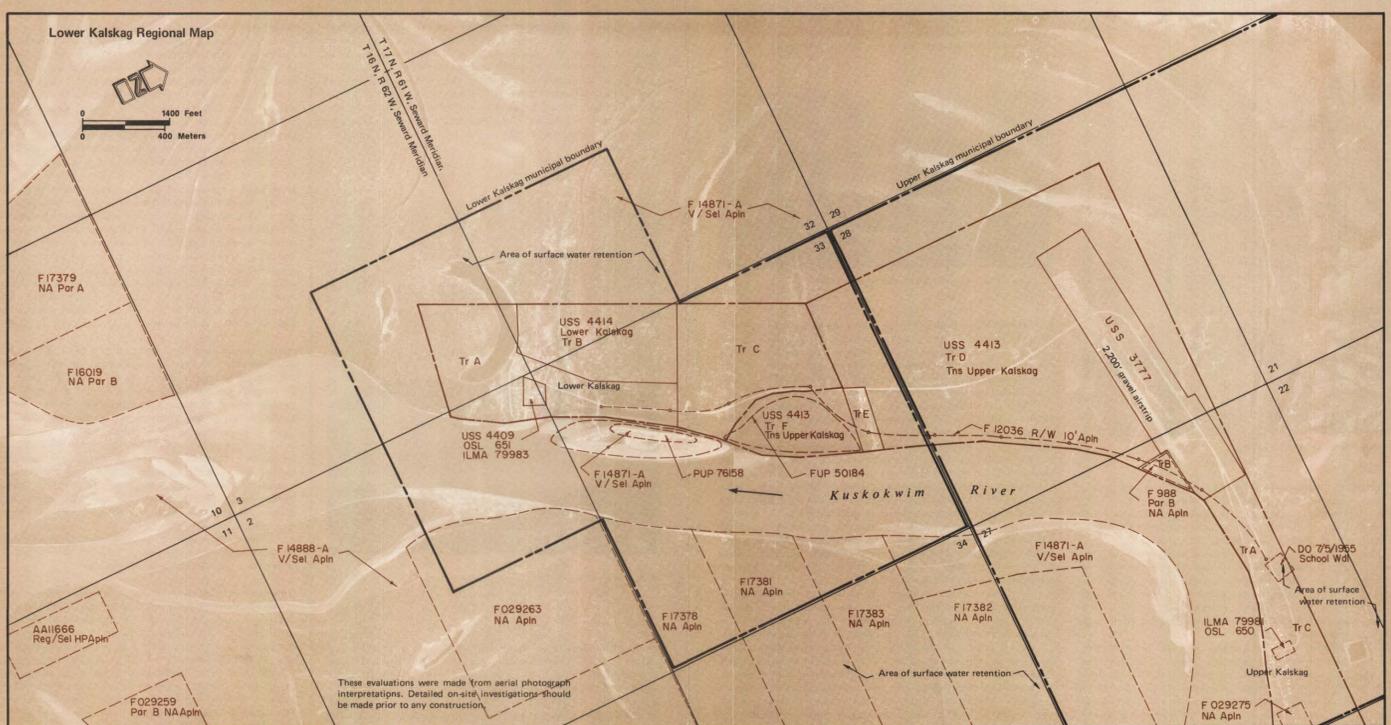
The Regional Map at right, printed at a scale of 1:16,800 (1 in. = 1,400 ft.), clearly shows the village and the surrounding area. This photograph shows that Lower Kalskag has one road connecting Lower Kalskag with the airstrip and Upper Kalskag. The photo shows surface cover has been removed within the village area, while the surrounding land is fully covered with vegetation. The village lies on a slight incline away from the river as evidenced by the lake drainage channel. Surface water drains into the river or is retained by the heavy vegetation. There are no indications of permafrost in the photo.
