COMMUNITY MAP OSCARVILLE

60° 43' N 161° 47' W Elevation 20'

The preparation of this document was financed through an appropriation from the Alaska State Legislature to the Department of Community and Regional Affairs, Municipal and Regional Assistance Division, 1990.

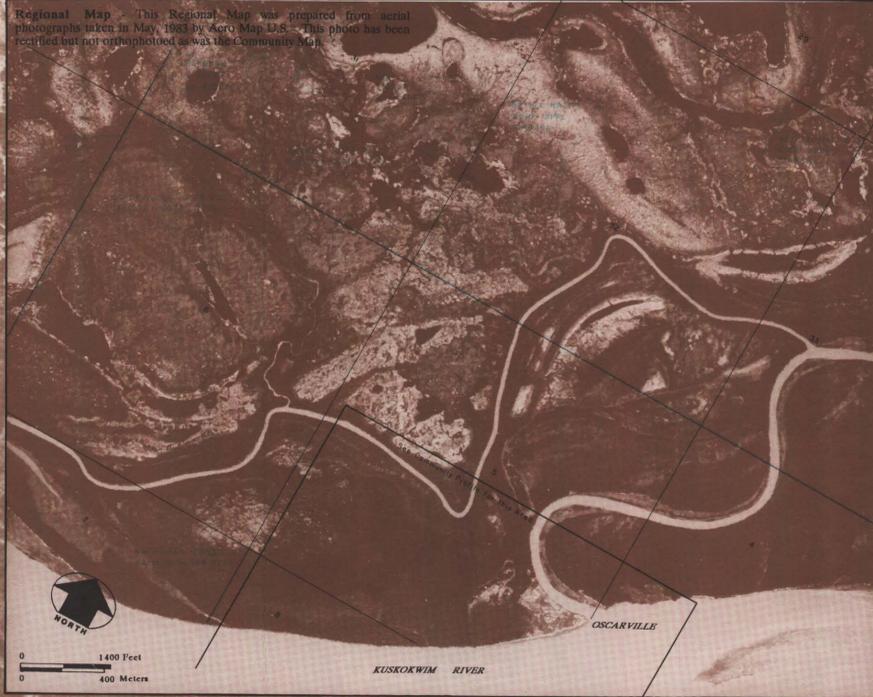
The orthophoto map shown here was prepared from aerial photography taken in 1983 by Aero Map U.S. An orthophoto is an aerial photograph which has been corrected (rectified) by removing the distortions that are present in the original photographs. Distortions in aerial photographs can be caused by aircraft tip or tilt as the photos are being taken, and changes in ground elevation.

1. Teachers' Quarters
2. Old School/Teachers' Quarters
3. Generator/Utility Building
4. School
5. Generator Plant
6. Community Hall/Washeteria (Not in Use)
7. Shop and Wellhouse
8. Clinic
9. Traditional Council Office

Land Use (From Field Survey June 1990)	
	Residential
	Commercial
	Public
	Public Use Area
	Multiple Use
	Vacant Structure
	Constructed after the 1983 orthophotos were made, location estimated and approximate
Note: Structures not outlined or color coded have been determined to be minor accessory structures or dilapidated buildings.	
	Boardwalk
	Sewer Line
	Fuel Line
	Powerline
•	Pole
x	Earth Station
	Active Erosion

Flood Information: The entire community is in the floodplain of the Kuskokwim River. After the 1989 flood, three Corps of Engineers' High Water Marks (COE-HWM) were located as follows:

- No. 1 -- On the upstream corner of the school.
- No. 2 -- On the utility pole upstream from the new school.
- No. 3 -- On the utility pole downstream from the new school.

The recommended minimum building elevation is one foot above the COE/HDM's (the 1989 flood level).
