Community Base Map—Maps are needed to show land use, ownership, location of utilities, and to plan for future village improvements. These maps can be prepared by either surveying the land on the ground, by enlargement of aerial photos, or by a combination of both. Air photos can be taken at various heights. The height determines the extent of the area covered by the photograph.

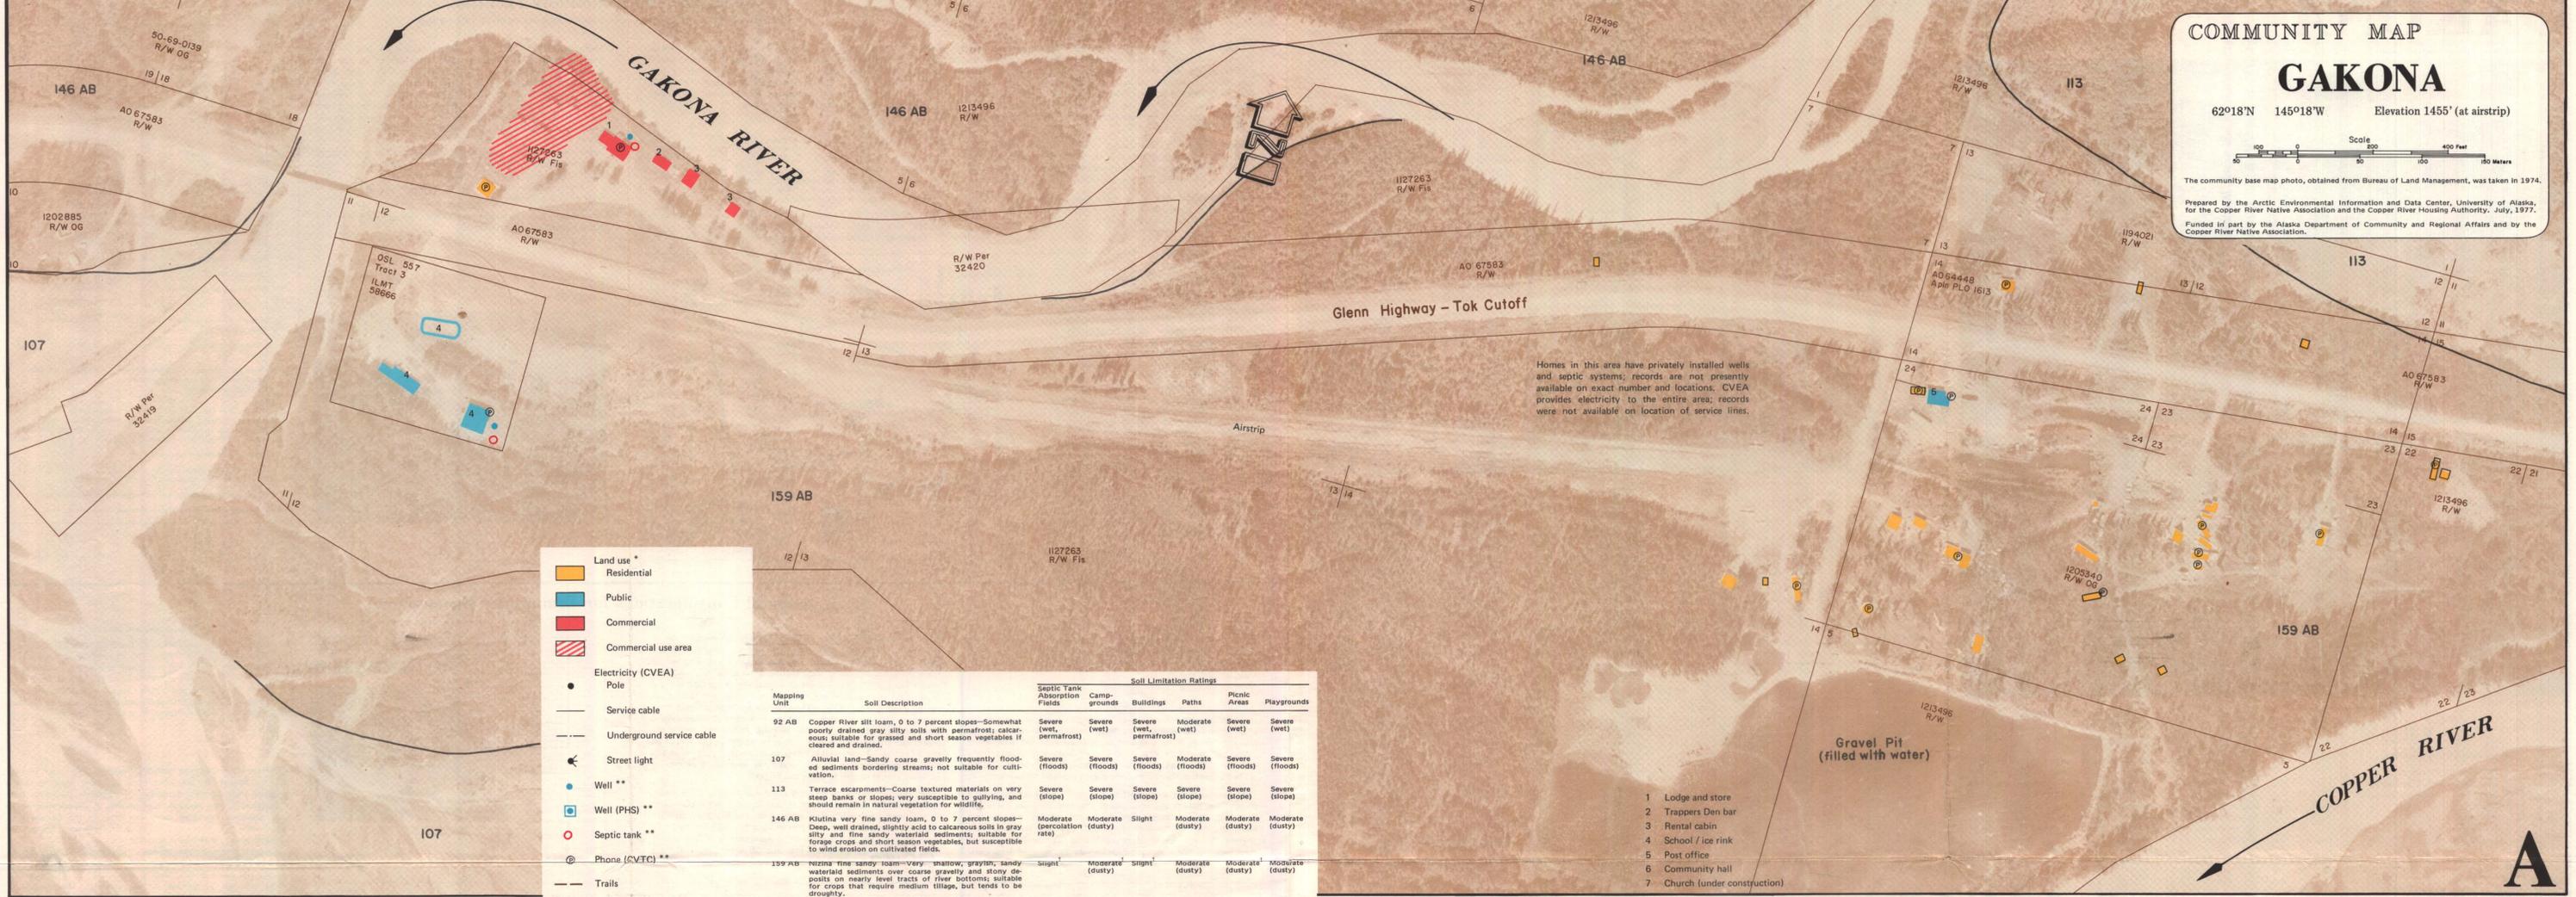
- Land use * Residential
- Public
- Commercial
- Commercial use area
- Electricity (CVEA) Pole
- Service cable
- Underground service cable
- ⦿ Street light
- Well **
- ⊕ Well (PHS) **
- ⊙ Septic tank **
- Ⓢ Phone (CVTC) **
- Trails
- Land status (BLM; numbers refer to surveys, applications, patents, etc.)
- New road (location approximate)
- Soils (Boundaries are approximate; on-site testing is necessary prior to construction of facilities.)
- ▨ Fish wheel sites
- * Data collected by AEIDC field survey.
- ** Shows occurrence but not actual location.

This community base map (above) was prepared from a photograph that was enlarged to a scale of 1:2,400 (1 in. = 200 ft.). This map was used to locate the present utilities, homes, and various community services and can be used in the future to evaluate the area for village expansion and to locate sites for new construction. The map also shows the area around the village, including old trails, drainage patterns, and type of vegetative cover. This kind of data is very important in the development of community growth and expansion as well as to the understanding of some of the environmental conditions that presently affect the community.

Note: This community base map has been prepared from low altitude aerial photographs which contain unavoidable distortions in scale. Property and utility information have been generalized from many sources and may contain minor inconsistencies. This map should not be construed as a survey.

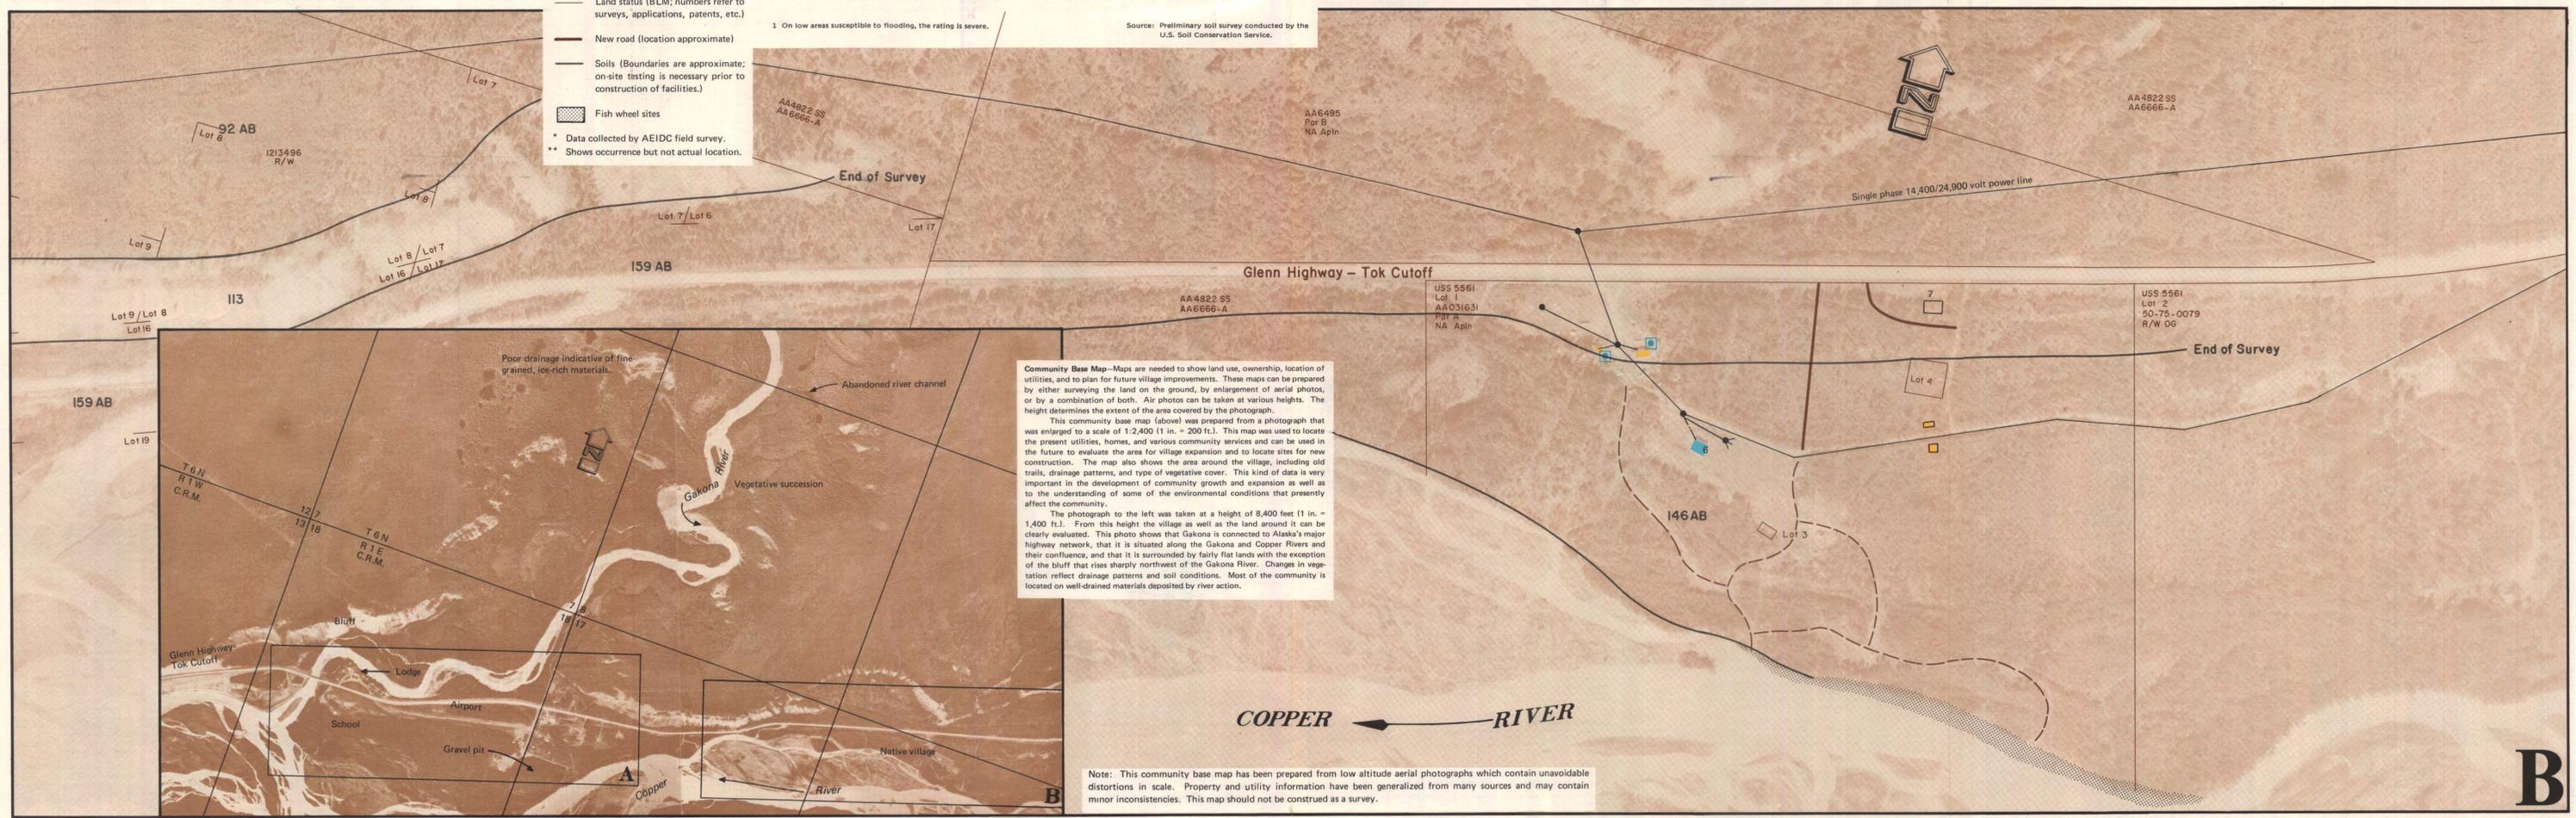
- ▨ Poor drainage indicative of fine-grained, ice-rich materials.
- Abandoned river channel
- Vegetative succession

The photograph to the left was taken at a height of 8,400 feet (1 in. = 1,400 ft.). From this height the village as well as the land around it can be clearly evaluated. This photo shows that Gakona is connected to Alaska's major highway network, that it is situated along the Gakona and Copper Rivers and their confluence, and that it is surrounded by fairly flat lands with the exception of the bluff that rises sharply northwest of the Gakona River. Changes in vegetation reflect drainage patterns and soil conditions. Most of the community is located on well-drained materials deposited by river action.
