COMMUNITY MAP

NAPAIMUTE

61°32'N 158°41'W Elevation 200'

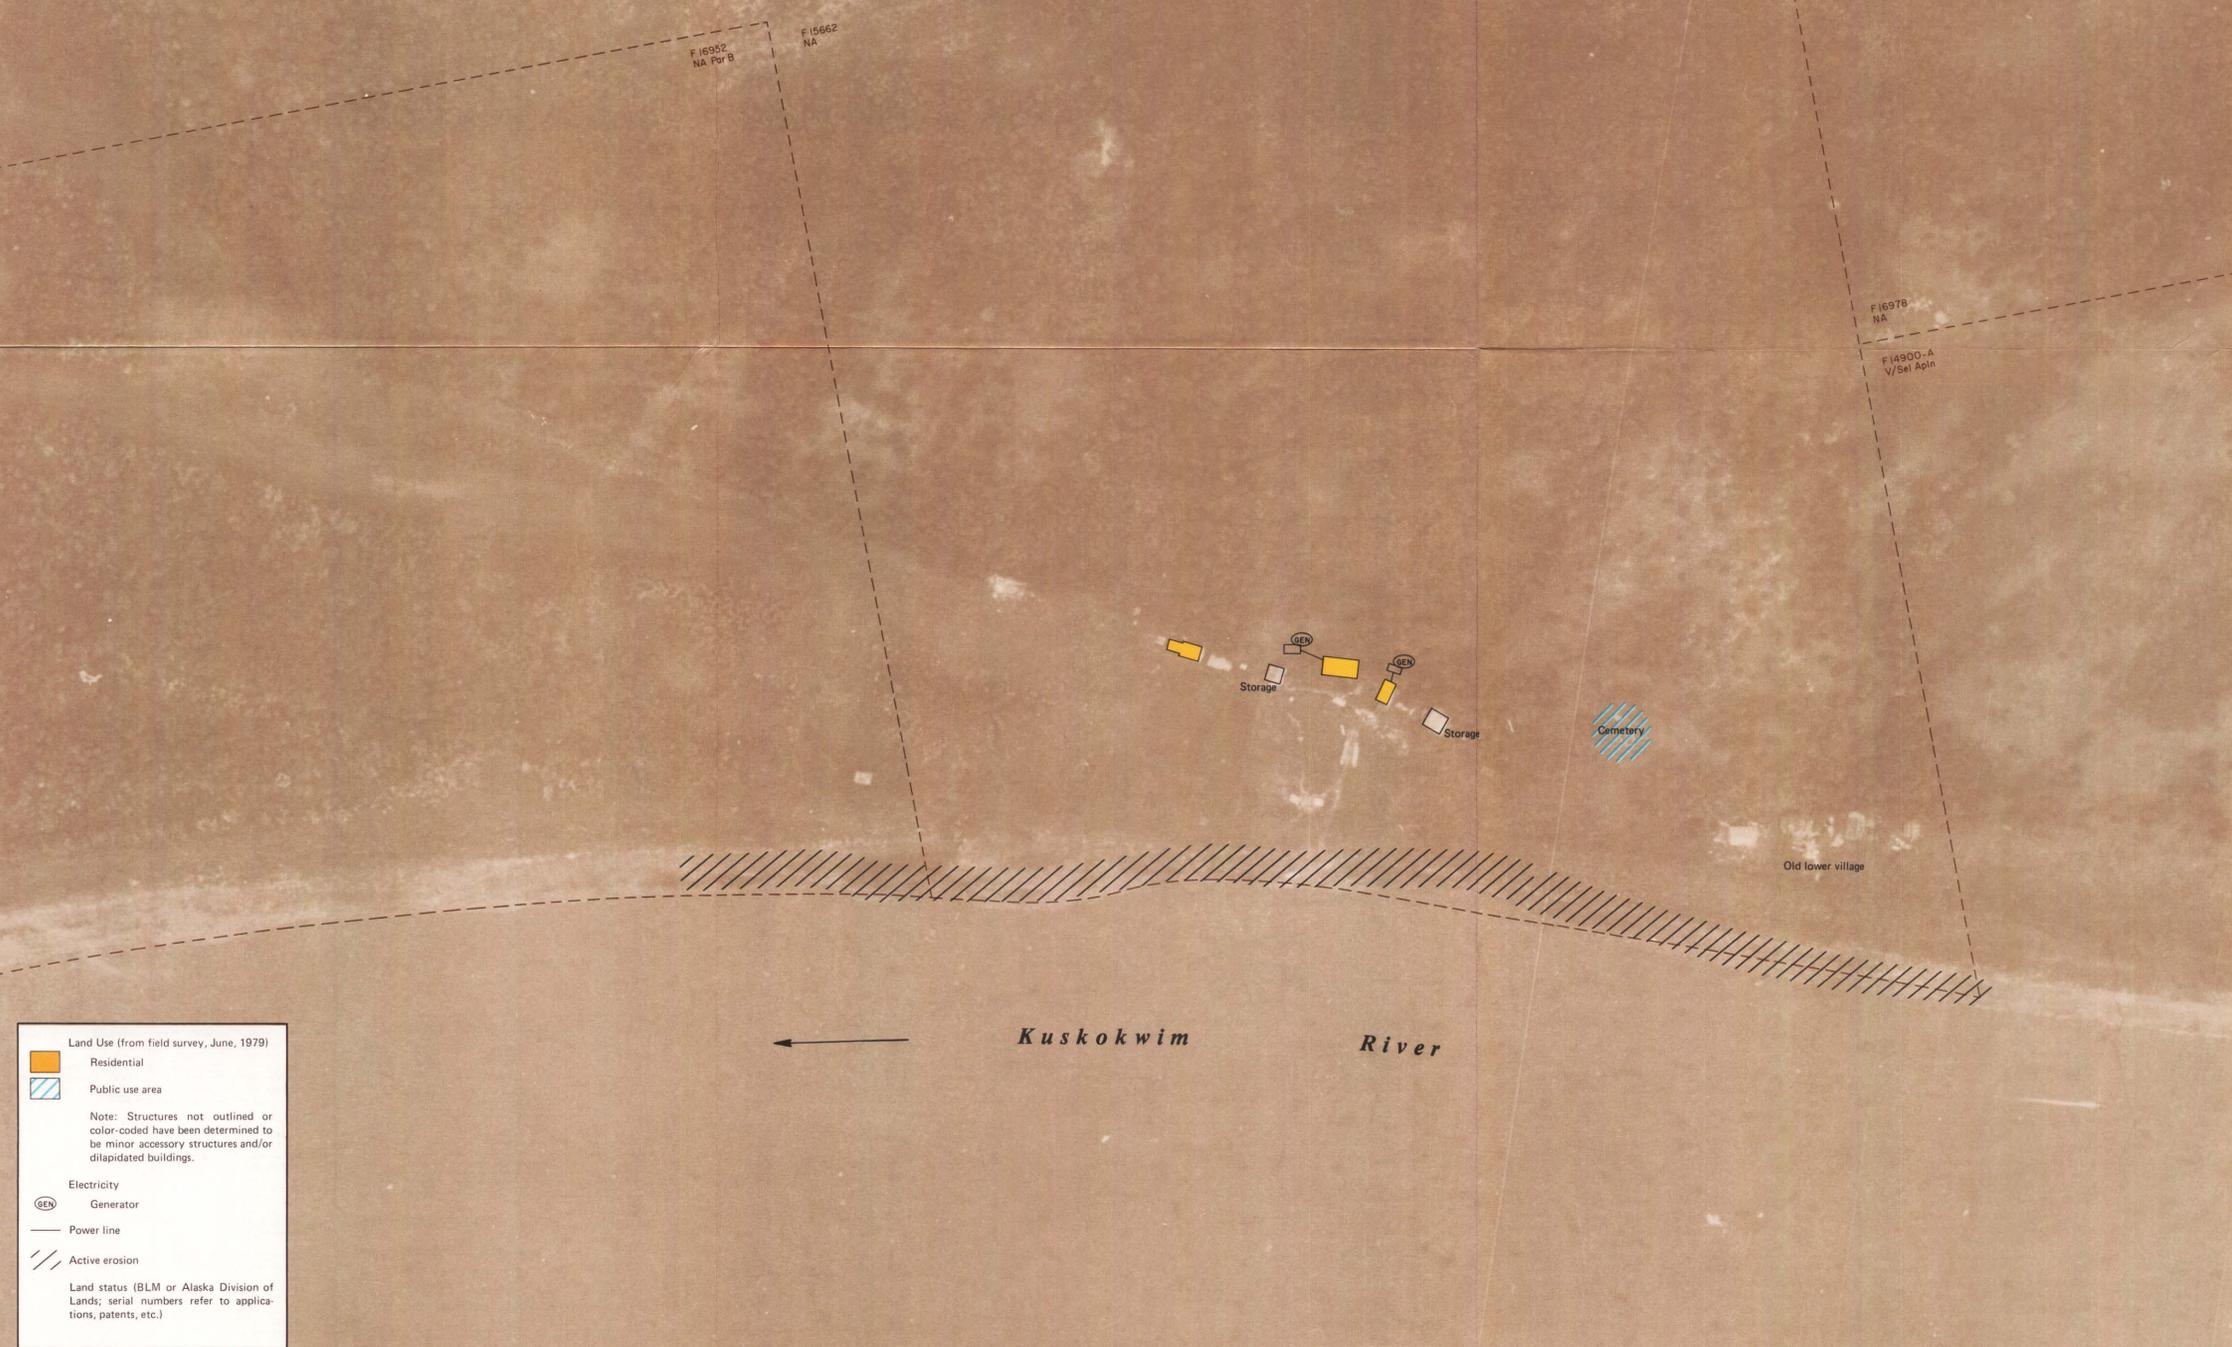
The Community Map shown here was prepared from a BLM aerial photograph taken in 1975 at a height of 8,400 feet and enlarged to a scale of 1:1,200 (1 in. = 100 ft.). This map has been used to locate the present utilities, residential and commercial development, public facilities and to portray other information which will aid in evaluating the area for new construction and for potential village expansion.
