# COMMUNITY MAP TUNTUTULIAK

60° 20' N 162° 40' W Elevation 15'

Not to Scale  
Tuntutuliak  
1990-1991  
V. 1/24/91

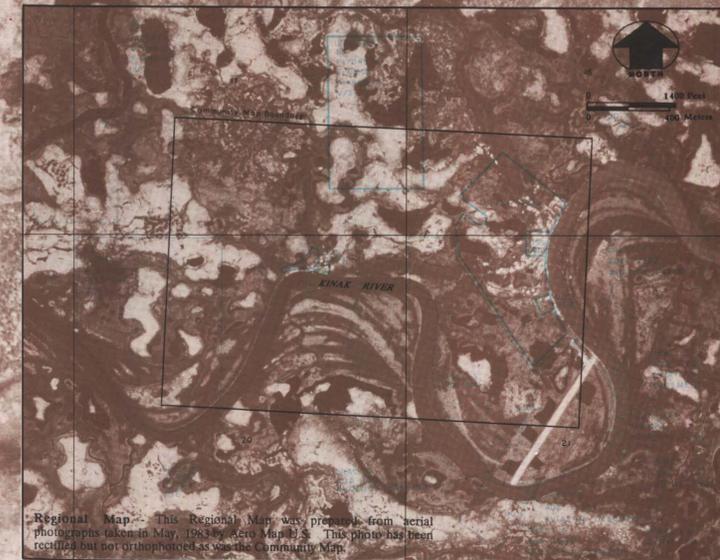
**Regional Map** - This Regional Map was prepared from aerial photographs taken in May, 1983 by Aero Map U.S. This photo has been rectified, but not orthophotographed as was the Community Map.

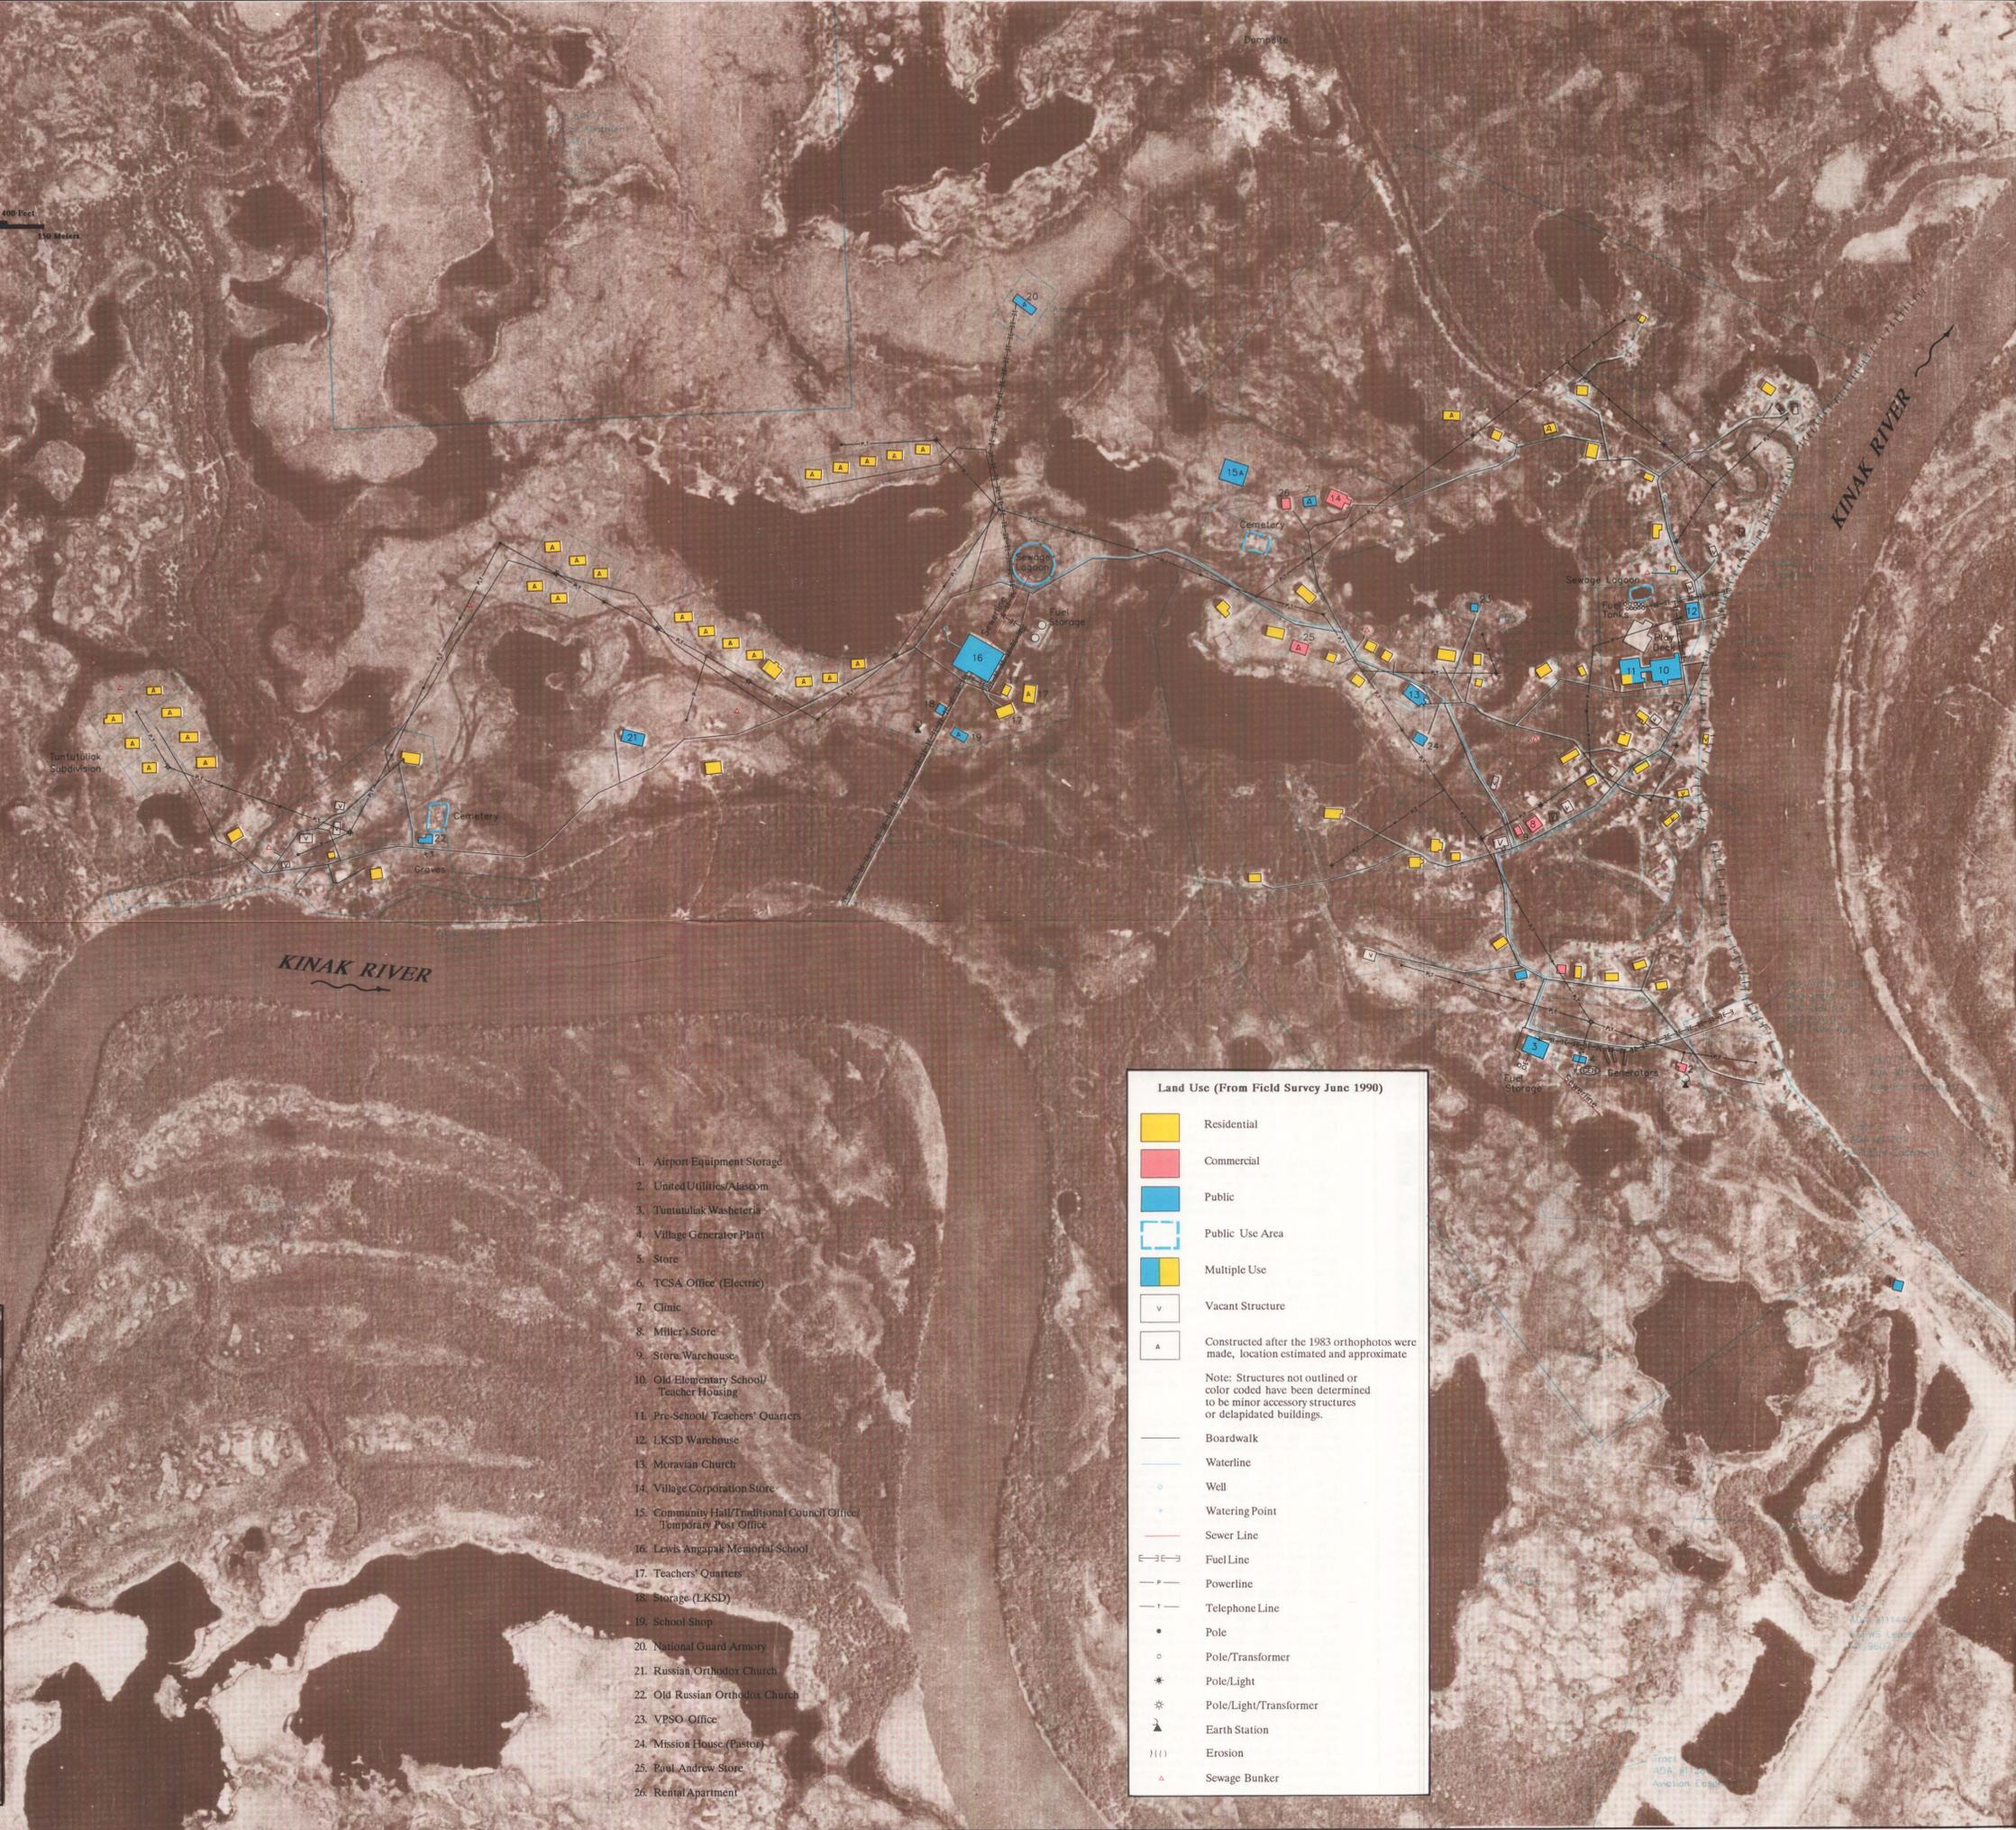
**Community Map** - This map is useful in illustrating land use patterns, land status, the location of utility lines, water resources, waste disposal sites, public facilities and other community improvements. It also provides an understanding of some of the natural features and hazards that affect community improvement and expansion.

The orthophoto map shown here was prepared from aerial photography taken in 1983 by Aero Map U.S. An orthophoto is an aerial photograph which has been corrected (rectified) by removing the distortions that are present in the original photographs. Distortions in aerial photographs can be caused by aircraft tip or tilt as the photos are being taken, and changes in ground elevation.

The advantage of orthophotos is that they are more accurate than the original aerial photographs from which they are made. As a result, the location of structures shown, or measurements obtained from orthophotos are more accurate. For example, a distance measured between two points on an orthophoto will nearly match the surveyed distance between the same two points.

1. Airport Equipment Storage
2. United Utilities/Alascom
3. Tuntutuliak Washeteria
4. Village Generator Plant
5. Store
6. TCSA Office (Electric)
7. Clinic
8. Miller's Store
9. Store Warehouse
10. Old Elementary School/Teacher Housing
11. Pre-School/Teachers' Quarters
12. LKSD Warehouse
13. Moravian Church
14. Village Corporation Store
15. Community Hall/Traditional Council Office/Temporary Post Office
16. Lewis Angapak Memorial School
17. Teachers' Quarters
18. Storage (LKSD)
19. School Shop
20. National Guard Armory
21. Russian Orthodox Church
22. Old Russian Orthodox Church
23. VPSO Office
24. Mission House (Pastor)
25. Paul Andrew Store
26. Rental Apartment

**Land Use (From Field Survey June 1990)**

- Residential
- Commercial
- Public
- Public Use Area
- Multiple Use
- v Vacant Structure
- A Constructed after the 1983 orthophotos were made, location estimated and approximate

Note: Structures not outlined or color coded have been determined to be minor accessory structures or dilapidated buildings.

- Boardwalk
- Waterline
- Well
- Watering Point
- Sewer Line
- Fuel Line
- Powerline
- Telephone Line
- Pole
- Pole/Transformer
- Pole/Light
- Pole/Light/Transformer
- Earth Station
- Erosion
- Sewage Bunker
